1998 Ford Ranger

In-depth Vehicle Occupant Report

The University
of Michigan
Transportation
Research Institute

Case Veh. (A): 1998 Ford
Type: Ranger XLT, 4x2 pickup
Driver: 20-year-old female
CDC: 10-LFEW-3

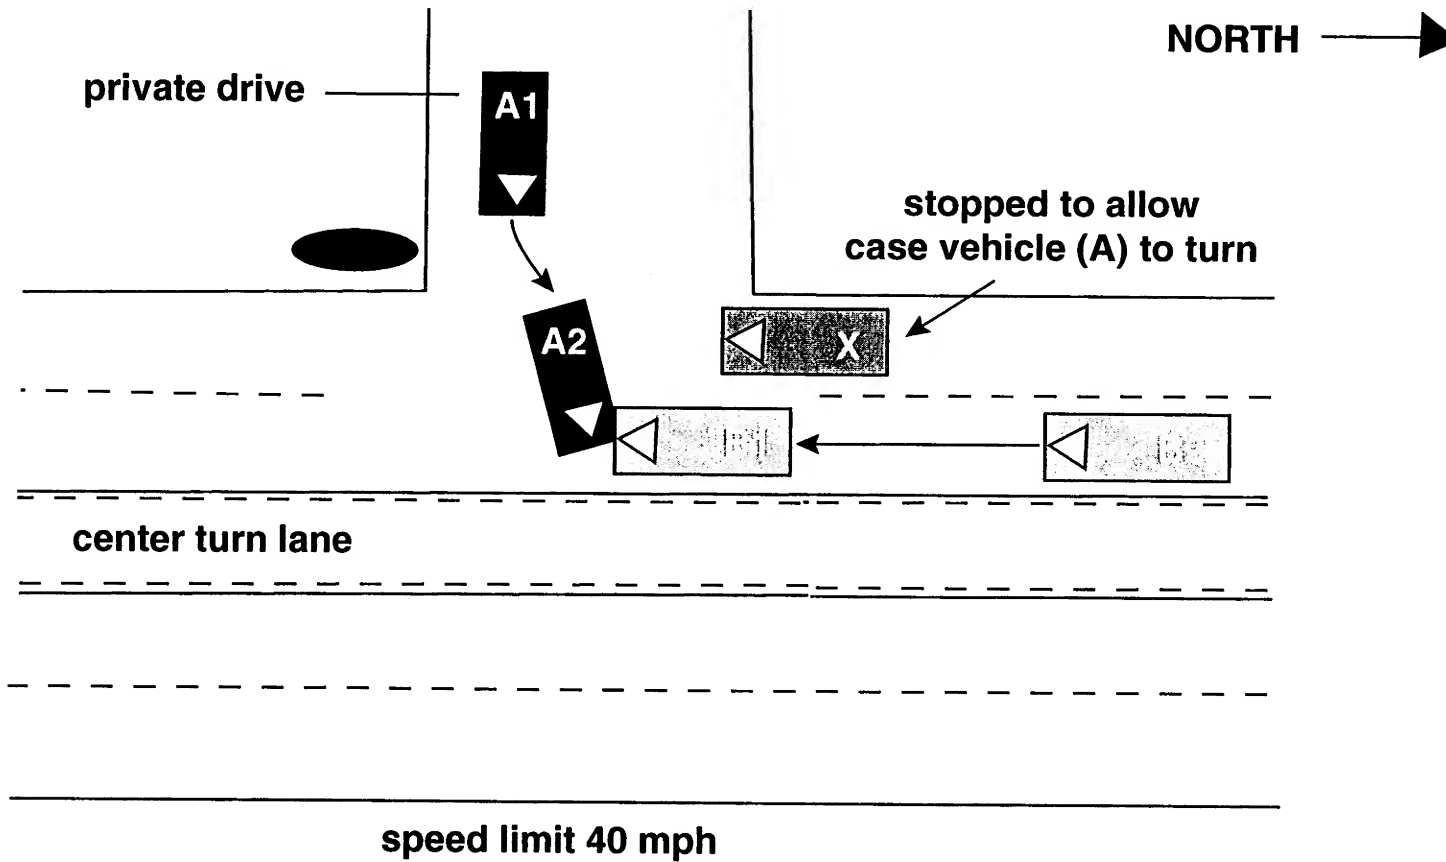
(Slide 1, 2) The weather was clear, the roads were dry, and it was daylight. Case vehicle (A) was stopped facing east in a private drive at its intersection with the southbound lanes of a 5-lane roadway, and the driver was waiting to make a left turn onto the roadway. Vehicle (B) was traveling south in the left southbound lane of the five-lane road at an unknown speed. Vehicle (X) was traveling southbound in the right southbound lane and had stopped to allow case vehicle (A) to exit. As vehicle (B) proceeded through the intersection, the driver of case vehicle (A) pulled out to make a left turn, so as to travel north. The driver of vehicle (B) was unable to avoid striking the front left side of case vehicle (A) with its right front.

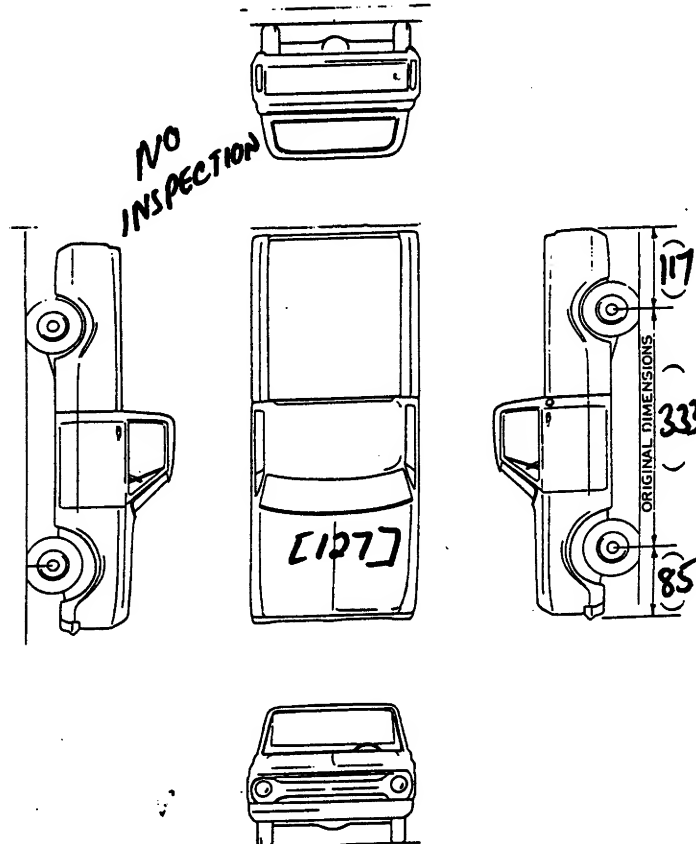
VEHICLE DAMAGE

(Slide 8) Damage to the front left side of case vehicle (A) was moderate with a maximum crush of 53 cm to the left-front fender. The direct damage began at the left-front bumper corner and extended rearward 99 cm along the left side of the fender. (Slide 9, 10) The left-front fender was deformed, the left-front wheel was damaged, and the left

wheelbase was reduced 10 cm. The driver's door was deformed, and jammed closed. (Slide 11) The hood was damaged, both hood hinges were deformed, and the rear edge of the hood was elevated. The lower-left portion of the windshield was cracked, probably due to deformation of the cowl area. (Slide 12) In the front, the front bumper was crushed, the left headlight assembly was broken, and the grille was deformed. (Slide 13, 14) On the right side, the front fender was deformed and shifted to the right. There was no other damage to the right side and no change in the right wheelbase.

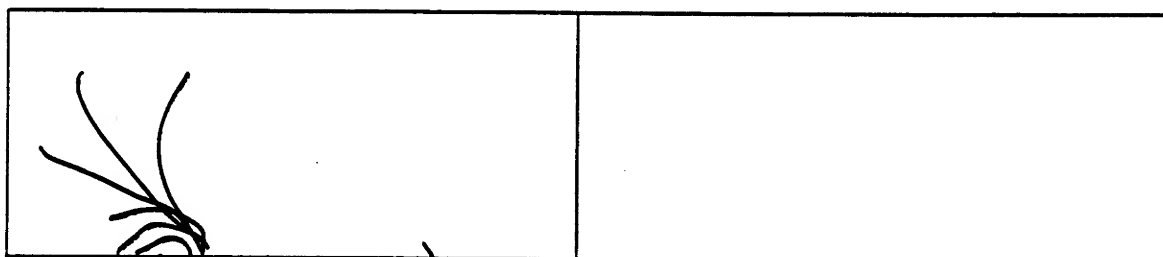
LOCATE AREA OF WINDSHIELD INTEREST OR DAMAGE WITH DIMENSIONS (VERTICAL & HORIZONTAL) ON THIS DIAGRAM OF THE WINDSHIELD AS VIEWED FROM INSIDE.

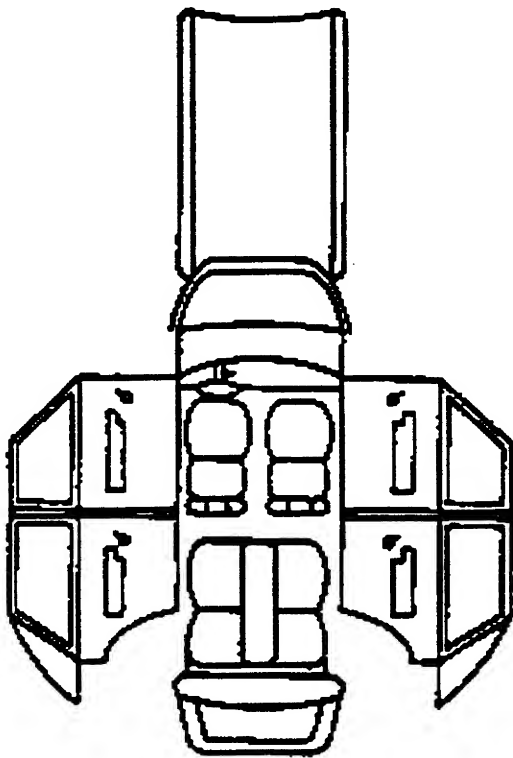
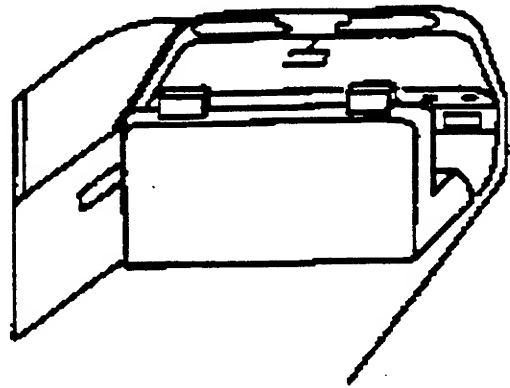
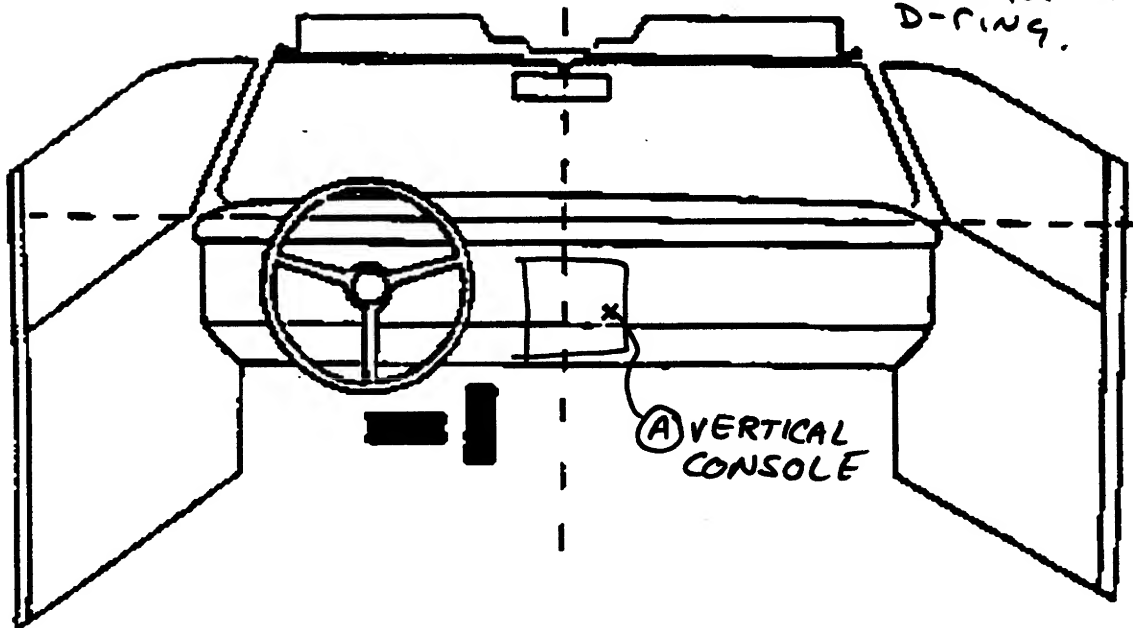
VEHICLE OCCUPANT CONTACT DIAGRAM

(Slide 15, 16) This vehicle is equipped with steering-wheel and passenger frontal-impact airbags which deployed during the left-side impact. There was no damage to the airbag skins, and no occupant contact marks were found. (Slide 17, 18) There was no damage to the steering wheel and no rotation of the steering column. (Slide 19, 20, 21, 22) There was no damage to the upper, mid, or lower portions of the instrument panel, or glove compartment. (Slide 23) There was a scuff mark on the center vertical console, located on the right-front occupant area, from occupant knee contact. There was no other interior damage and no intrusions were noted.

DR: UPPER POSITION
ON B-PILLAR

RF: UPPER POSITION
ON B-PILLAR

RF: BLACK 4N SH. BELT
GOOD SCARS ON
D-RING.

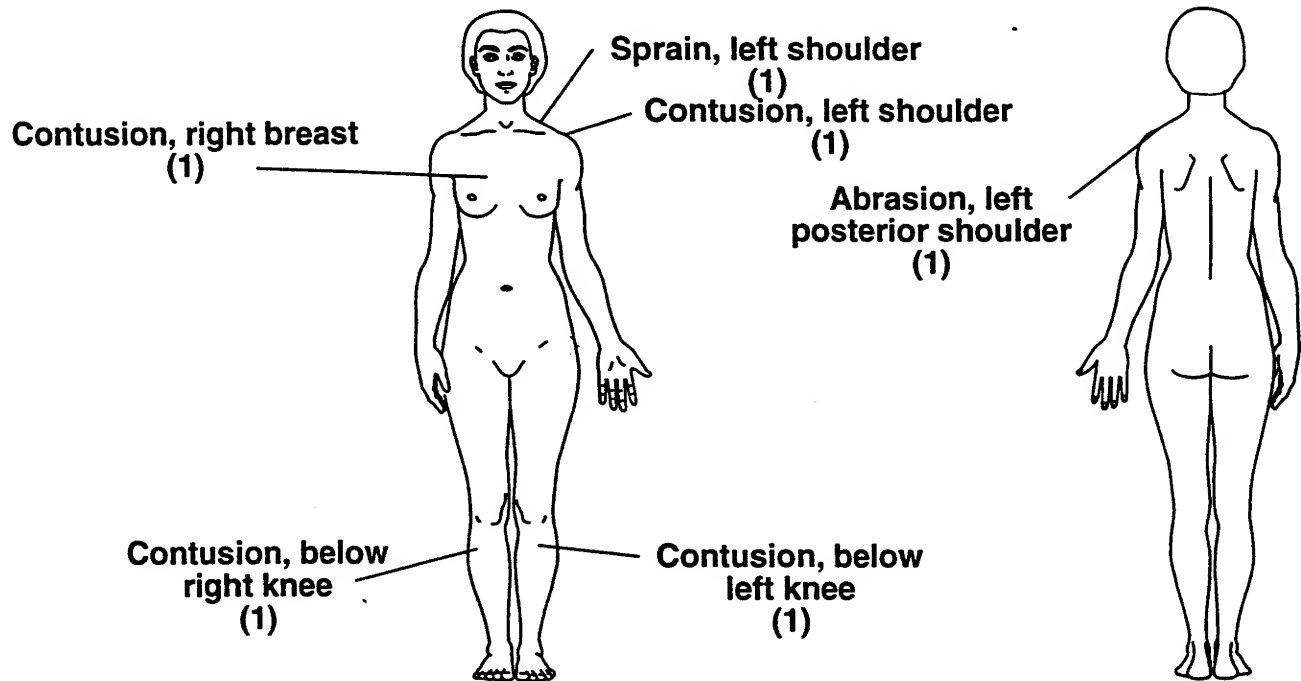
INDICATE LOCATION OF INJURIES.

(Slide 24) The 20-year-old female driver was wearing the 3-point belt and the airbag deployed. She reportedly had the seat in the full-rear track position, and her hands at the 11:00 and 1:00 positions on the steering wheel, but did not know where the tilt steering wheel adjustment was set. The shoulder-belt anchor point was adjusted to the upper position on the B-pillar. During the impact, she moved to the left and forward relative to the vehicle interior. She sustained a sprain and contusion to her left shoulder, from the shoulder portion of the 3-point belt or the door interior. She sustained an abrasion to her left posterior shoulder from an unknown source. She sustained a contusion to her

right breast from the shoulder portion of the 3-point belt. She sustained contusions below her left and right knees from contact with the knee bolster.

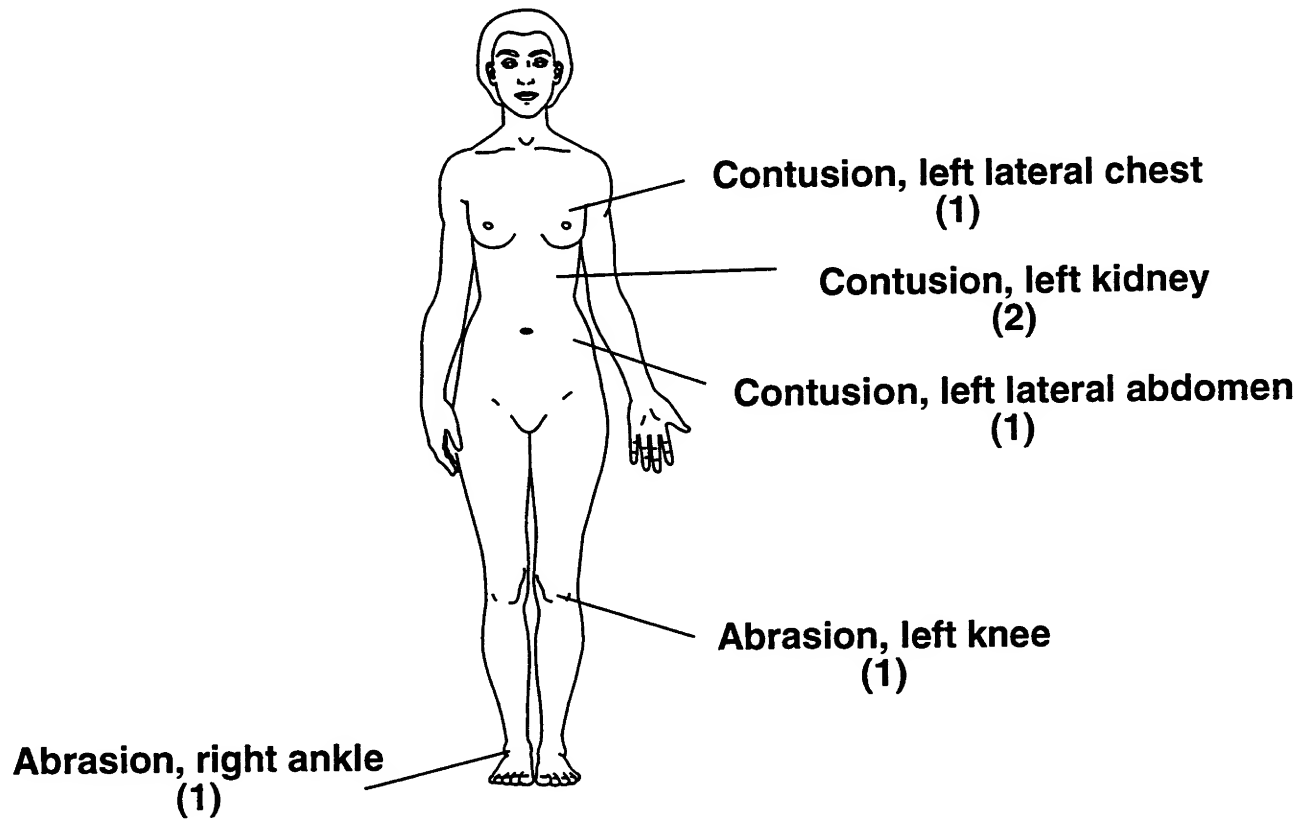
INDICATE LOCATION OF INJURIES.

(Slide 25, 26) The 21-year-old female right-front passenger was wearing the 3-point belt, as evidenced by marks on the shoulder-belt webbing from the D-ring, and marks on the D-ring from the shoulder-belt webbing. Also, the airbag deployed. (Slide 27) She reportedly had the seat in the full-rear track position, and the shoulder-belt anchor point adjusted to the upper position on the B-pillar. During the impact, she moved to the left and forward relative to the vehicle interior. She sustained a contusion to the left lateral area of her chest, from the shoulder portion of the 3-point belt. (Slide 28) She sustained a contusion to her left lateral abdomen, and a contusion to her left kidney, probably from the lap portion of the 3-point belt, or the center armrest. (Slide 29) She sustained an abrasion to her left knee, from contact with the vertical console, as evidenced by scuff marks to the console. She sustained an abrasion to her right ankle, possibly from contact with the area beneath the instrument panel.
